ASBESTOS BUILDING INSPECTION REPORT PRE-DEMOLITION BUILDING SURVEY

PERFORI	MED FOR:
Greater Mohawk Valley	Land Bank
500 East Main Street - S	Suite 2A
Little Falls	
PROJE	CT SITE: y Land Bank
46 Division Street	
Fort Plains	, New York
0 4	1 5 1 9

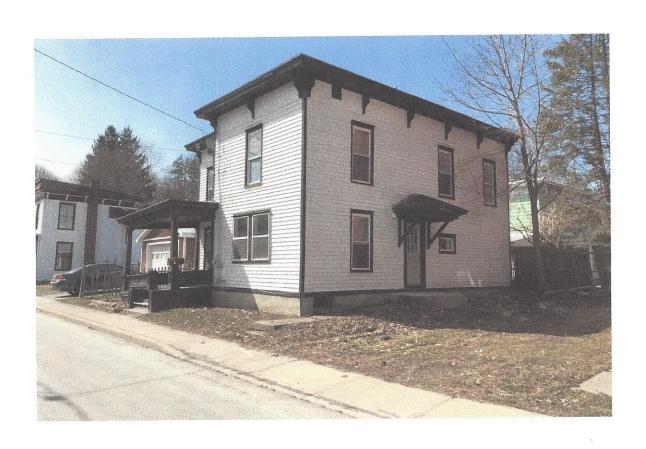
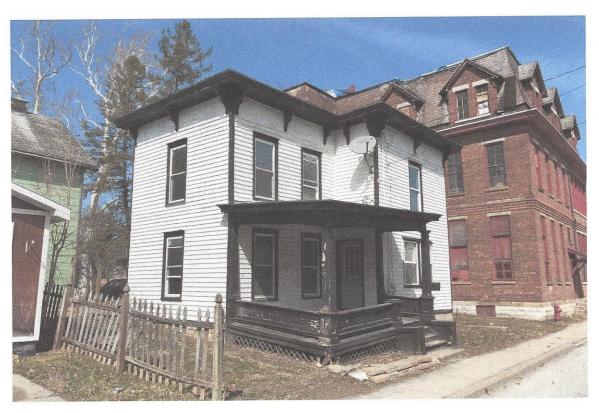
Floor Plan Drawings and Pictures

Sample Number	Material Sampled	Condition	Lab Results (% Asbestos)	Estimated Quantity
19-9a	aluminum roof coat - front porch roof	damaged	9.70% Chrysotile	160 sq'
20-9b	aluminum roof coat - front porch roof	same as 19-9a	same as 19-9a	same as 19-9a
21-10a	aluminum roof coat - main roof - bottom layer	good	9.20% Chrysotile	1100 sq'
22-10b	aluminum roof coat - main roof - bottom layer	same as 21-10a	same as 21-10a	same as 21-10a
M. 4
