REPORT OF PRE-RENOVATION ASBESTOS INSPECTION

Location of Inspection:	20 Lake Street Richfield Springs, New York 13439
Client/ Building Owner:	Greater Mohawk Valley Land Bank 500 East Main Street, Suite 2A Little Falls, New York 13365
Alpine Project #:	19-23711-A
Material or Area Inspected:	Whole building
Asbestos Materials Tested:	Cement board, plaster, drywall compound, wall tile adhesive, 9″x9″ floor tile, floor tile, linoleum, flooring, sink insulation, roofing (assumed)
Non-Asbestos Containing	
Materials:	White blanket, ceramic floor tile, stone foundation mortar, stucco, paper over tarpaper, drywall, textured ceiling, ceramic wall tile & grout, carpet mastic, covebase & mastic, plastic wall tile adhesive, shower adhesive, black membrane (basement), tar paper (basement), wire insulation, window glazing, shingles
Date(s) of Inspection: Report Date:	January 10, 2019 January 29, 2019
Inspection Performed By:	Alpine Environmental Services, Inc. 438 New Karner Road Albany, New York 12205

Inspector(s):	Paul Van Zandt: NYSDOL Cert.#AH95-02581 NYS Department of Labor Certified Asbestos Inspector

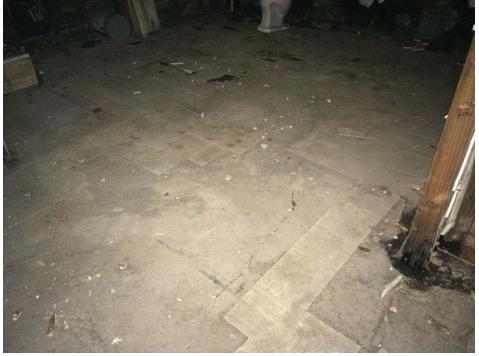
9"x9" Floor Tile - Basement

Any materials not sampled during this inspection should be considered suspect unless sampled and determined to be non-asbestos. All asbestos containing materials must be abated prior to the demolition/renovation of any of the structures unless performed under a variance issued by the NYS Department of Labor. Disturbance/Abatement of any asbestos containing materials, as well as necessary air monitoring, must be performed by a NYS DOL licensed contractor, in accordance with state and federal regulations (NYS DOL ICR 56 and US EPA 40 CFR).

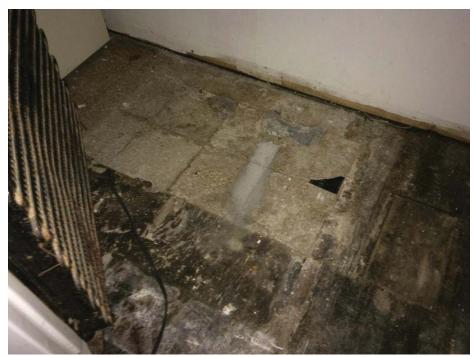
9"x9" Floor Tile – Kitchen 113

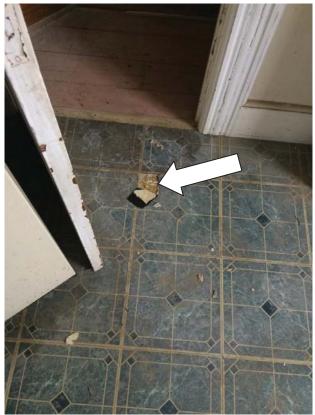
Floor Tile (Bottom Layer) – Kitchen 200

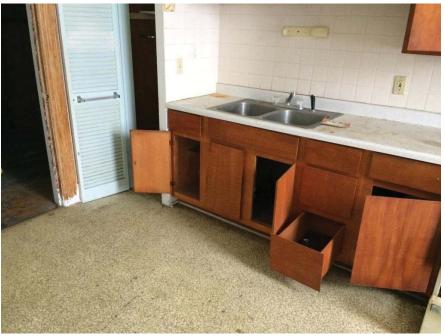
Linoleum, Sink Insulation & Wall Tile Adhesive – Kitchen 203

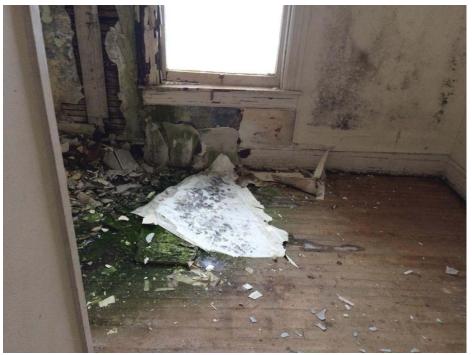
Plaster – Room 207

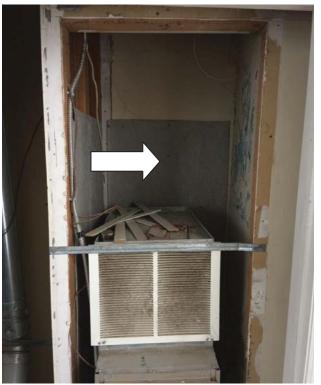
Cement Board – Room 200 Heater Closet

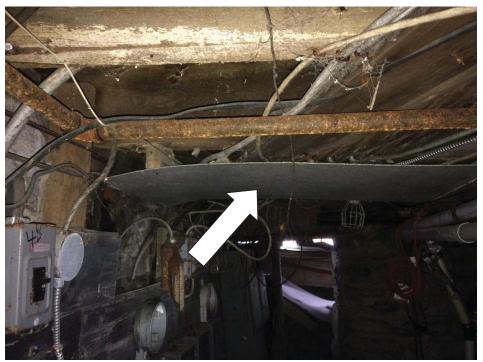
Cement Board – Basement Ceiling
